# **Electrical Energy & Safety Audit Report of Kharupetia College, Kharupetia, Darrang, Assam**

**Audit Period:** 21/03/2023 – 01/04/2023

**Audited by:** MONADITYA

## **CERTIFICATE OF ENERGY AUDIT**

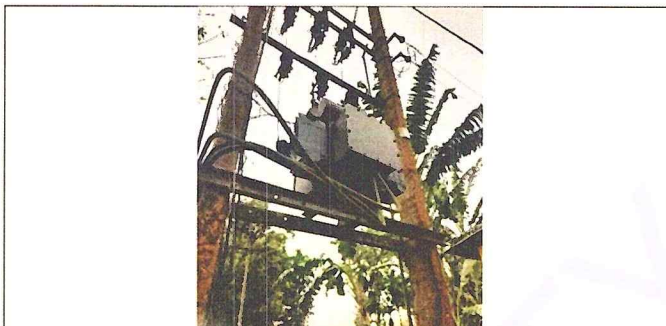
The primary source of power supply for the Kharupetia College campus is from a 63KVA, 11/0.415KV pole-mounted transformer. The transformer's LT output is drawn out to an overhead line. Multiple tapings are taken from this OH line for power supply to various parts of the college campus.

Photo: 63KVA, 11/0.415KV pole-mounted transformer for power supply to the college campus

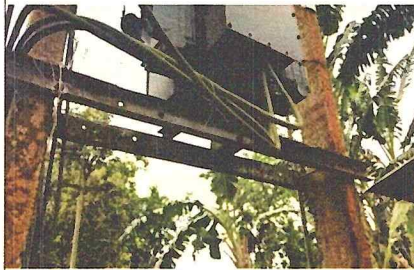
Sl. No.	Observation	Photo
1.	The transformer substation area was found to be fully covered by weeds and creepers. During the audit, the substation area was partially cleaned up under our direction.	
2.	The DO fuses for the transformer have been replaced by simple wires and have no barrels.	
3.	One of the three Line type lighting arresters is missing.

Sl. No.	Observation	Photo
4.	<p>The naked GI wire drawn from the Line Type LAs to its earth-pit is touching the GI channels mounted on the PSC DP structure. The transformer and other substation accessories are all mounted on this structure. In the event of a lightning strike, there is a possibility of this naked wire energizing the mounting channels and equipment mounted on this DP structure with high voltage lightning strikes.</p> <p>This GI wire should be replaced by a 11 or 33KV insulated 1 core 75sq.mm Cu or Al cable to avoid such a hazard.</p>

- 2) There some major safety weaknesses were observed in the transformer substation. These weaknesses should be relayed to the APDCL for necessary rectification / revamping. (Elaborated below in **Section 4.2 (a)**)

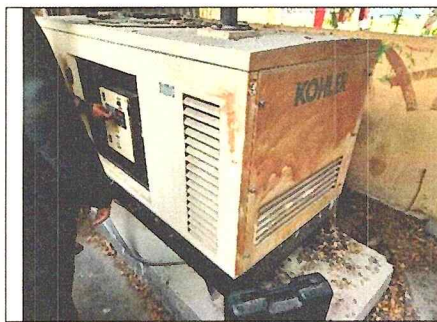
DG set's Capacity: **10 KVA**

Make: Kohler Power Systems.

Model: KK10 II

Photo: DG set-1

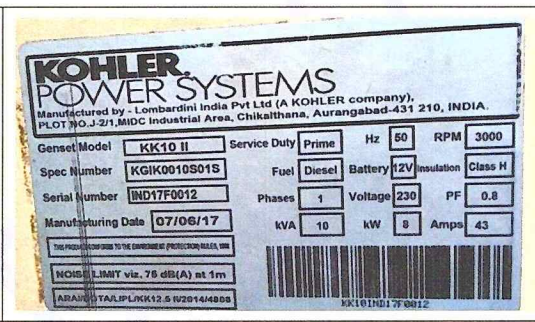
Photo: Nameplate of the DG set-1

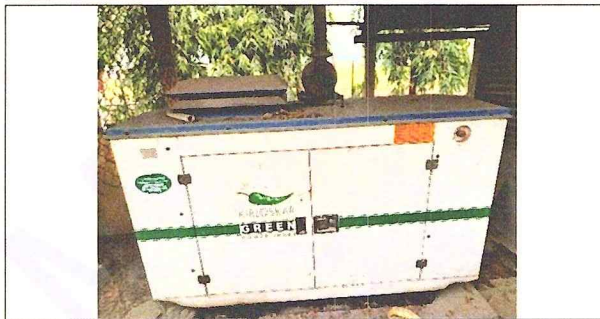
The DG-2 is non-functional and kept disconnected. The DG-1 is currently being used to provide backup power to the DG-2's loads.

This DG set is non-functional and kept disconnected.

Photo: DG set-2

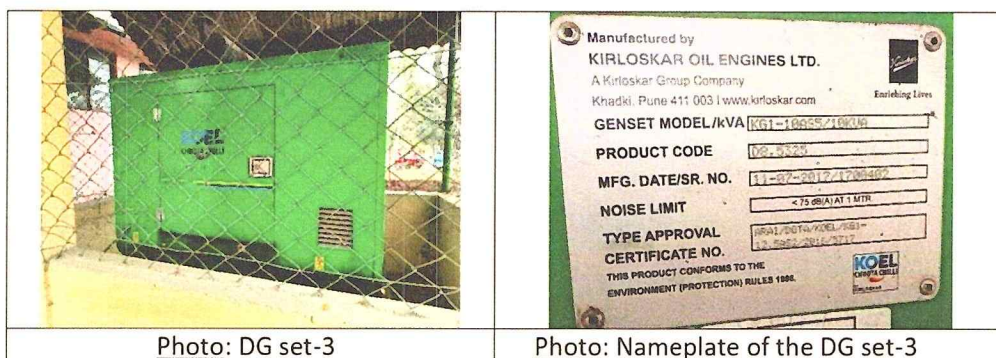
The ratings of this DG set is as given below:

DG set's Capacity: **10 KVA**

Make: Kirloskar Oil Engines Ltd.

Model: KG1-10AS5

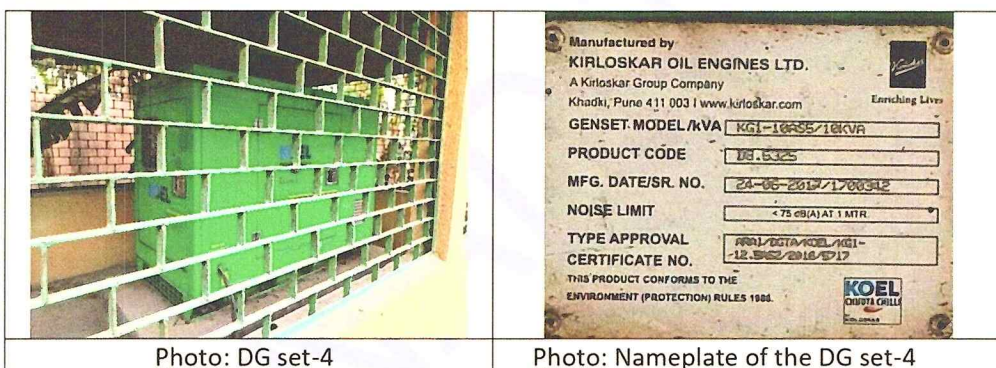
The ratings of this DG set is as given below:

DG set's Capacity: **10 KVA**

Make: Kirloskar Oil Engines Ltd.

Model: KG1-10AS5

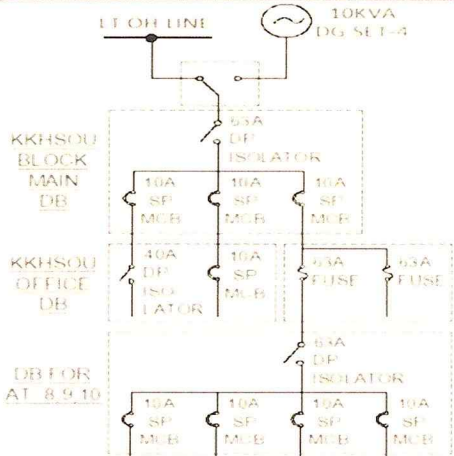
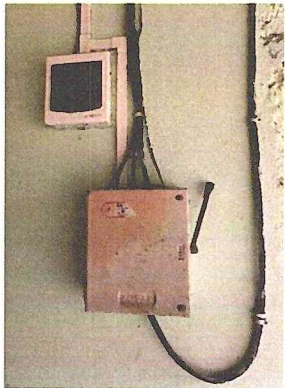
<p><u>Fig:</u> SLD of power distribution of KKHSOU block</p>	<p><u>Photo:</u> Grid / DG-4 Changeover</p>

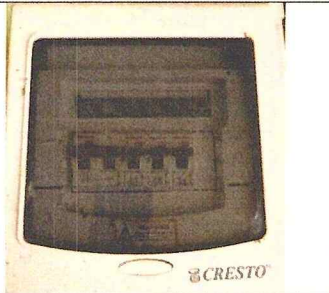
<p><u>Photo:</u> Main DB of KKHSOU block</p>	<p><u>Photo:</u> KKHSOU office DB</p>	<p><u>Photo:</u> Fuse switch and DB for power supply to AT-8, 9, 10</p>

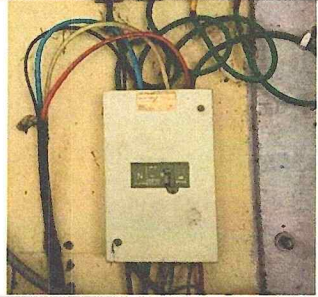
<u>Photo: Main Incomer MCCB</u>	<u>Photo: Fuses at Changeover incoming</u>	<u>Photo: Grid / DG-3 Changeover</u>

There are fuses and fuse switch boxes installed for the protection of some of the circuits in the college campus. These fuses are obsolete and need to be replaced with MCBs / MCCBs

of appropriate ratings. MCBs / MCCBs are reusable and offer better over-current protection to the circuits.

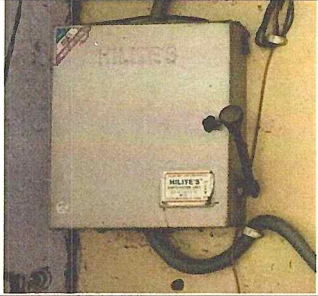
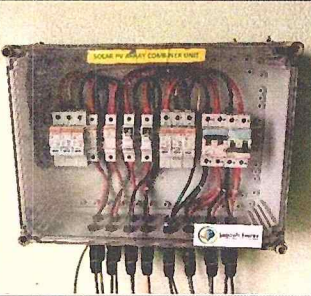
<u>Photo: Fuse switch at Changeover outgoing</u>	<u>Photo: Solar Array Combiner Unit</u>	<u>Photo: MCCB at Solar Inverter outgoing</u>

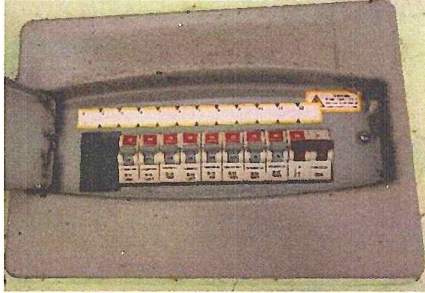
<u>Photo: DB#4 (near RCC-16)</u>	<u>Photo: DB#5 (near Digital Room-2)</u>

It is seen that the Distribution Boards (DBs) installed at the various blocks of the college have isolators as their Main Incomer Switch. These isolators provide no over-current protection for the power circuit. These isolators should be replaced by MCB switches of appropriate ratings.

A combination of MCB and Earth leakage protection switchgear ( RCCBs/ ELCBs etc.) may be put at the main incomer of these DBs. These RCCBs provide protection against any accidental human contact with the power circuit. These RCCBs should have a current sensitivity rating of 30mA to ensure human safety.

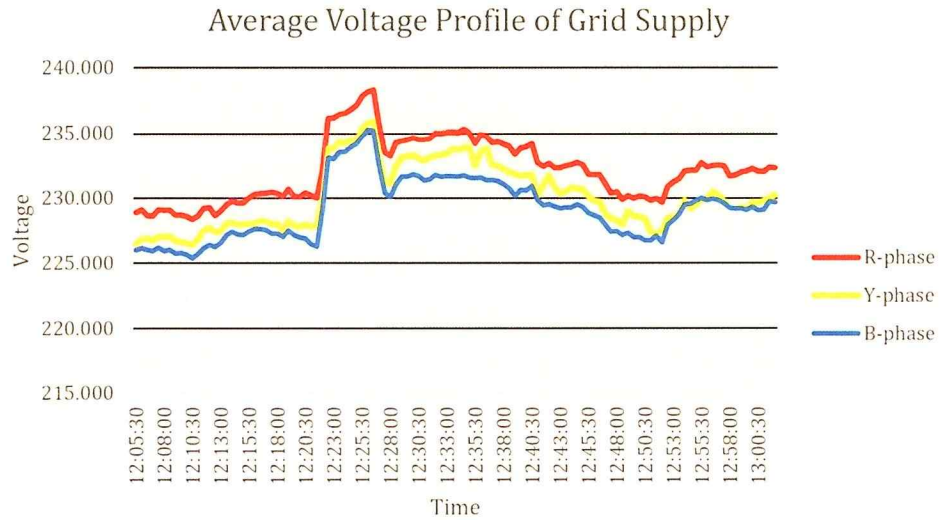
**Fig: Average Voltage Profile – Grid supply**

The average voltage of the Grid Supply as can be seen in the graph above is 230.49V (L-N). The voltage variation was found to be within 225.36 to 238.3 V.

- The transformer's voltage output was found to be within limit.
- The supply frequency and its variation was noted to be within limit.
- The Voltage THD levels were found to be within limit.
- **The Current THD levels of the Grid supply were found to be very high.**
- The neutral to ground voltage was found to be OK.

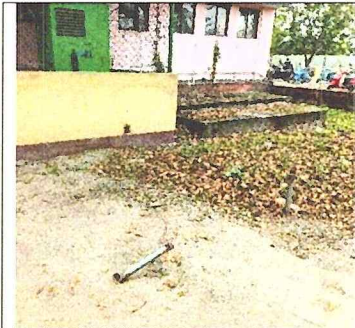
- The DG set-3 has one earth-pit each for its Body and Neutral earthing. The earthing connections for both the DG's Body and Neutral are provided through 8 SWG GI wires which are connected to 40mm dia. GI earth-pipes.
- These earth-pits do not have any protection chamber, hinged cover or watering funnel.
- The earth-pipe for the DG-3's Neutral earthing is broken and damaged. It needs to be replaced at the earliest.

Photo: DG-3's Body and Neutral earthing connections

The four DG sets should each be provided with two earth-pits each for their Body and Neutral earthing, as per prevalent industry standards.

The earthing conductors should be neatly drawn to the earth-pit and securely fastened to the earth-pipe.

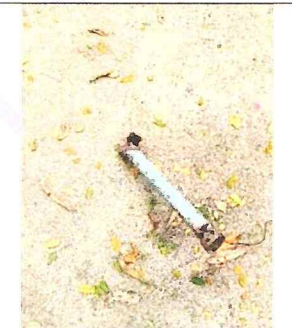
Photo: Earth-pit for DG-3's Neutral earthing.

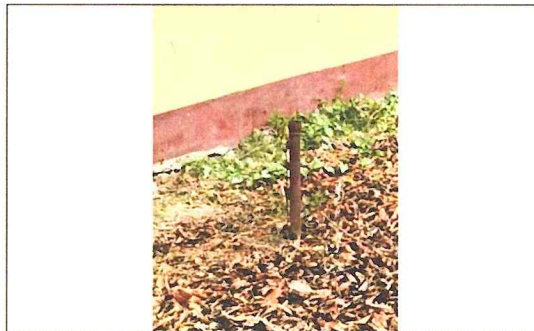
- The DG set-4 has one earth-pit for its Neutral earthing. The DG's neutral is connected through 8 SWG GI wires to a 40mm dia. GI earth-pipe.
- This earth-pit does not have any protection chamber, hinged cover or watering funnel.
- The earth-pit(s) for DG set-4 (if any) could not be traced out during the audit.

Photo: Earth-pit for DG-3's Neutral earthing.

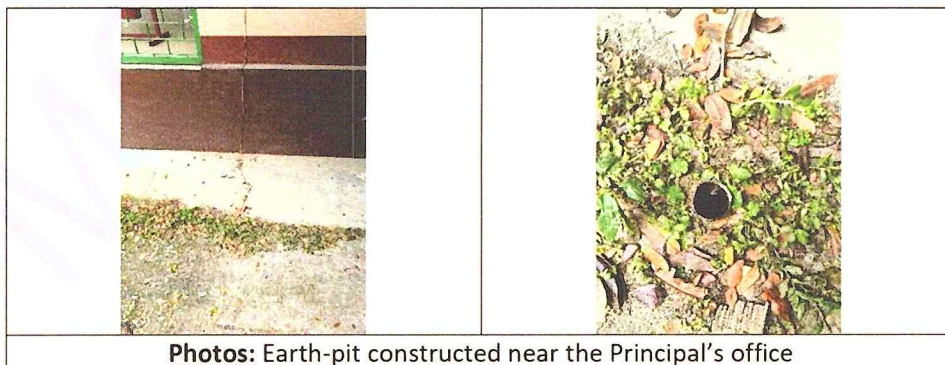
- Earthing connection to the switchboards at the Principal's Office block, Central Library block and Main College Building is provided through 1.5 sq.mm. copper wires. These copper wires are connected to a 40mm dia. GI earth-pipe buried near the Principal's office.
- This earth-pit does not have any protection chamber, hinged cover or watering funnel.
- The earth resistance value measured at this earth-pit was found to be extremely high (>100 Ohms).

**Photos:** Earth-pit constructed near the Principal's office

A complete revamping of the earth arrangement is necessary.

New earth-pits should be constructed for providing earthing to the switchboard circuits. These earth-pits should be placed at easily accessible locations.

Concrete earth-pit protection chambers having a hinged CI cover should be constructed for each of the new earth-pits.

The earth-pits should be regularly watered to keep the earth resistance values at a minimum. A funnel should be installed for pouring water into these earth-pits.
